## Fatigue Cracks in the 60-year-old steel Structure of the Bridge

*The paper shows the fatigue cracks that appeared in the steel girders under the orthotropic plate inside the bridge structure. During decades of exploitation, fatigue cracks developed both in the base material and in the welded joints of the steel girders. Frequent stress cycles due to increased traffic and occasional overloads caused the cracks to propagate over time. Fatigue cracks propagation shortens the life of the steel structure and drastically affects the structural integrity of the bridge. As an effective tool in the detection and evaluation of fatigue cracks in steel bridges, NDT (non-destructive testing) methods occupy a significant place. Non-destructive field methods used for the purpose of fatigue crack detection were magnetic particle testing and penetrant testing. The non-destructive metallographic method of the replica was used to assess the type of crack, and the examination of the taken replicas was carried out in the laboratory using light optical microscopy. Timely detection and repair of fatigue cracks in steel bridge components are key maintenance activities that can prevent potential failur

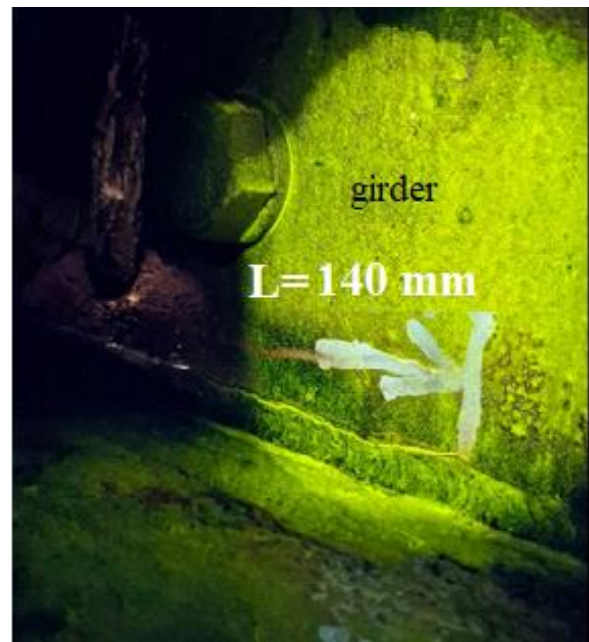
In this study, a Uniflux UF 230A yoked magnet, a powerful AC handheld magnet, was used for magnetic particle crack testing. The test was conducted in accordance with EN ISO 17638 [12]. The ambient temperature during the test was 20 °C. A fatigue crack in the heat affected zone of a steel girder under an orthotropic plate, detected by the MT method, is shown in Fig. 4.

Fig. 4 A fatigue crack in the heat affected zone of a steel girder under an orthotropic plate

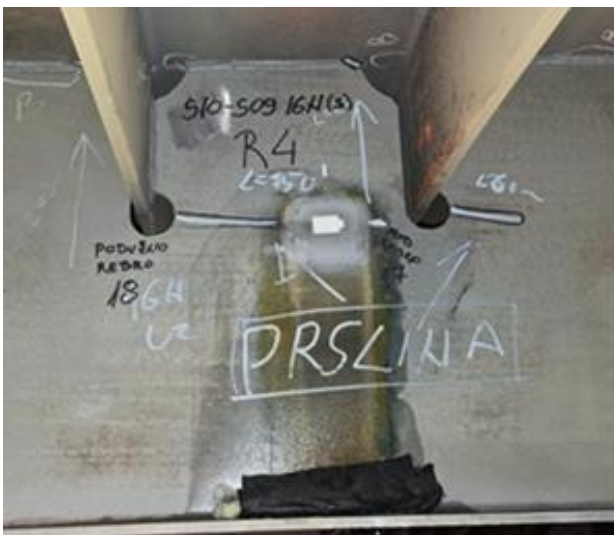
The NDT replica method included taking replicas (imprints) from the previously prepared surface on steel girders, from the zones that contained the cracks. A 4% alcoholic solution of nitric acid was used as a reagent for microstructure development. The analysis of the taken replicas was performed in the metallographic laboratory on a light optical microscope manufactured by Carl Zeiss, according to the ISO 3057 standard [14]. The cracks propagation ( $L_1=150$  mm and  $L_2=80$  mm) from the edges of the opening formed during the manufacturing process is shown in Fig. 6.

Fig. 6 The cracks propagation ( $L_1=150$  mm and  $L_2=80$  mm) from the edges of the opening formed during the manufacturing process
